**Holchem Technical Centre Report**  
**Summary of Trials to Investigate the Potential Value of the**  
**Bactiscan in the Food Industry.**

Report Reference	TS 456	21/5/2012
Report Prepared by	David Whitehead Jim Taylour	Formulation Chemist Technical Manager
Approved by	Steve Bagshaw	Technical Director
On behalf of	Holchem Laboratories Ltd Premier House 175 Grane Road Haslingden Rossendale Lancashire. BB4 5ER Tel: 01706 222288 Fax: 01706 221550 Email: <a href="mailto:info@holchem.co.uk">info@holchem.co.uk</a> Web: <a href="http://www.holchem.co.uk">www.holchem.co.uk</a>

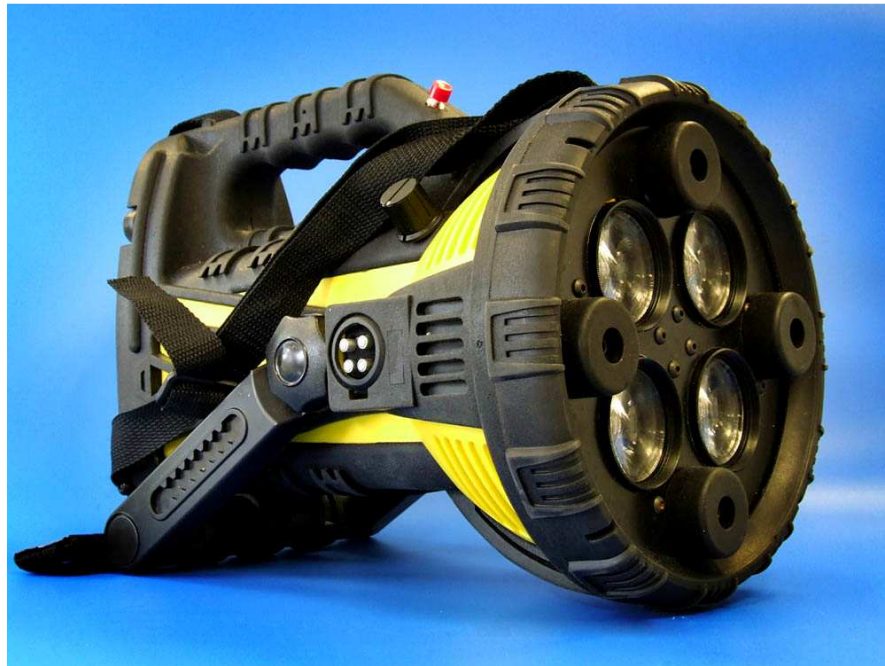
**Figure One**  
**The Bactiscan Unit**

Holchem were introduced to a technology produced by Easytesters in late 2011. In brief, the technology consists of a lamp using light sources at three wave lengths. By use of these wavelengths independently or in different combinations, it is claimed that microbial contamination on surfaces can be visualised. There is also a facility to use a variable flicker rate for the light sources to enhance the revealing of organisms. Figure One is a picture of the lamp.

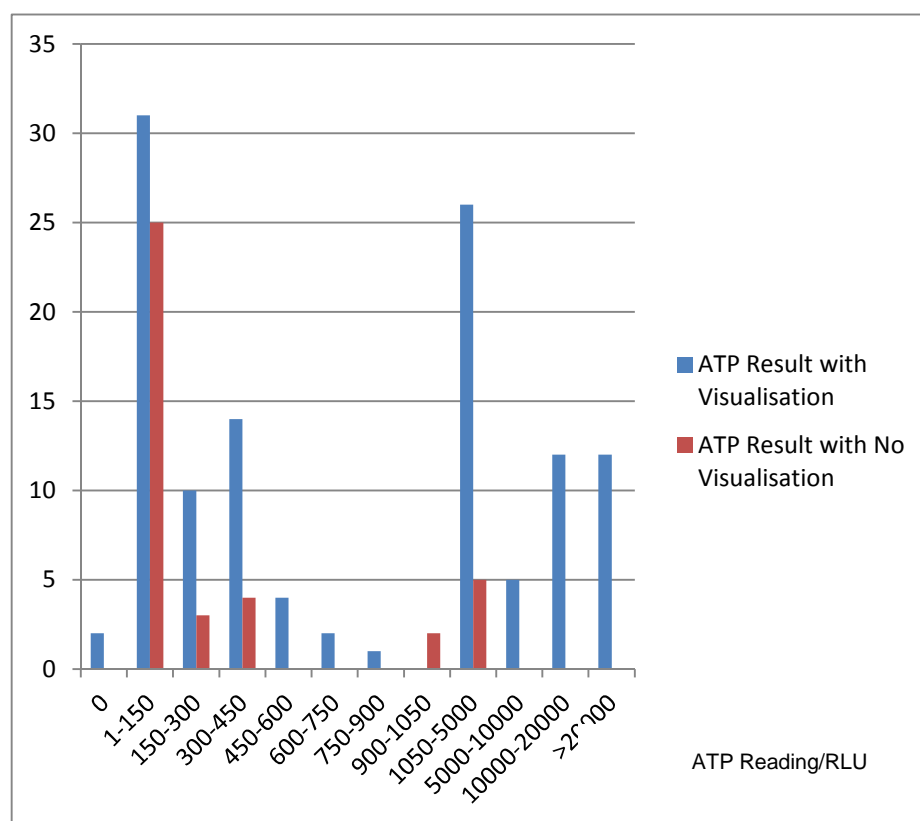
**Figure Five**  
Visualisations vs ATP Readings.

Figure Five compiles data from all studies and ranks numbers of visualisations against ATP counts. Two data sets are shown.

1. Number of ATP results for which visualisation was achieved.
2. Number of ATP results for which there was no apparent visualisation.

The data would seem to suggest that the Bactiscan can reveal micro-organisms down to very low ATP levels. Referring back to Table Two, it also appears to correlate to very low ACC data.

It is curious that at ATP readings of around 150RLU's and lower, it is possible to get significant apparent positive ATP results with no visualisation. However, within this region many ACC swabs came back as 0 or <10 Cfu/swab. This suggests that at low population densities the Bactiscan correlates well with conventional swabbing and plating, but less well with ATP data. As a control, we selected three clean un-used ATP swabs and observed apparent RLU reading between 50 and 150! Typically, readings at this level would not cause concern in high or low care environments, but it is perhaps indicative of the level of reliability of ATP technology.

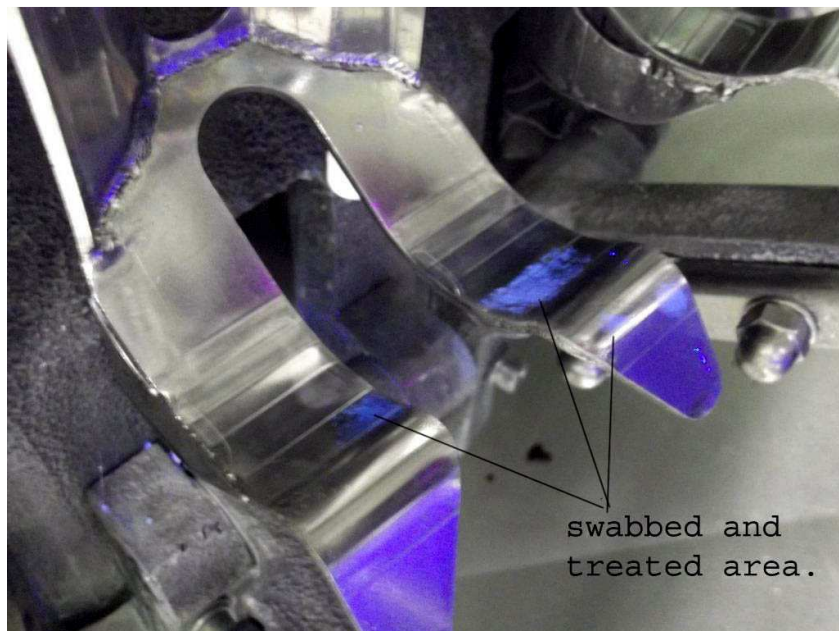
**Figures Six A**  
**EV Area Showing Visualisation of Soil**

Around a dirty EV line the Bactiscan performed as expected, that is it showed positive visualisation in locations where we expect high bacterial counts (Table Six and Figures Six A and B). Although spot cleaning with a chlorinated detergent reduces ATP readings, the soil loading is so high that the oxidising ability of the detergent does little to reduce ACC swab counts, although ATP data does fall. After destroying residual micro-organisms with **Perbac OPD**, bacterial population measured by swabs falls to zero, but both ATP and the Bactiscan continue to indicate a presence, presumably dead cells. There is anomalous data on a Dicer blade where there is no visualisation, with high bacterial loading we should see a positive result (lighting was dull).

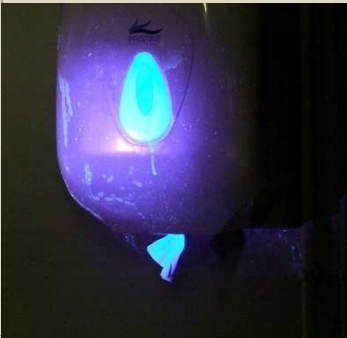
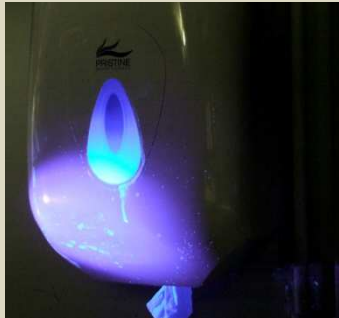
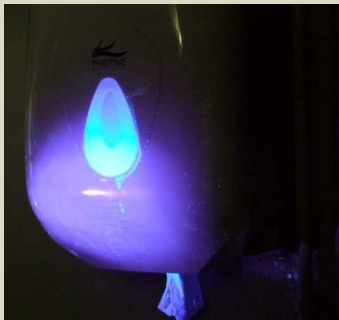
**Table Nine**  
**Towel Dispenser**

Data given in Table Nine shows a Towel Dispenser. Here the Bactiscan is we suspect creating a false impression. When initially inspected the unit appeared clean, but a positive hit was given under the Bactiscan light. ATP data was low, and subsequent swab data was insignificant. Sequential cleaning with **K1 Multi Purpose Cleaner** and **K2 Sanitiser** reduced the visualisation and indeed the apparent ATP and swab data. We think in this instance much of the material revealed by the Bactiscan was physical soiling and the low bacterial counts pose little health risk. However, there is clearly potential here for bacterial growth and in a high care environment such as a Care Home or Hospital, the Bactiscan may have benefit as an audit tool.

Location	ACC 22°C Cfu/swab	ACC 32°C Cfu/swab	ACC 37°C Cfu/swab	ATP/ RLU	Visualisation	
<b>Hospitality Area</b>						
Towel Dispenser Pre Clean Plastic surface No visible soil	0	1	0	440	Positive

Towel Dispenser Cleaned with K1 (Multipurpose Cleaner)	0	0	0	78	Positive

Towel Dispenser Cleaned with K2 Sanitiser (QAC Disinfectant)	0	0	0	51	Reduced
